CITY OF  
**SUMNER**  
WASHINGTON

**SPECIAL STUDY SESSION**  
**City Hall – 1104 Maple Street**  
**January 31, 2022 6:00 PM**

1. Overview & update of the Ryan House Renovation project

# Ryan House Feasibility Study

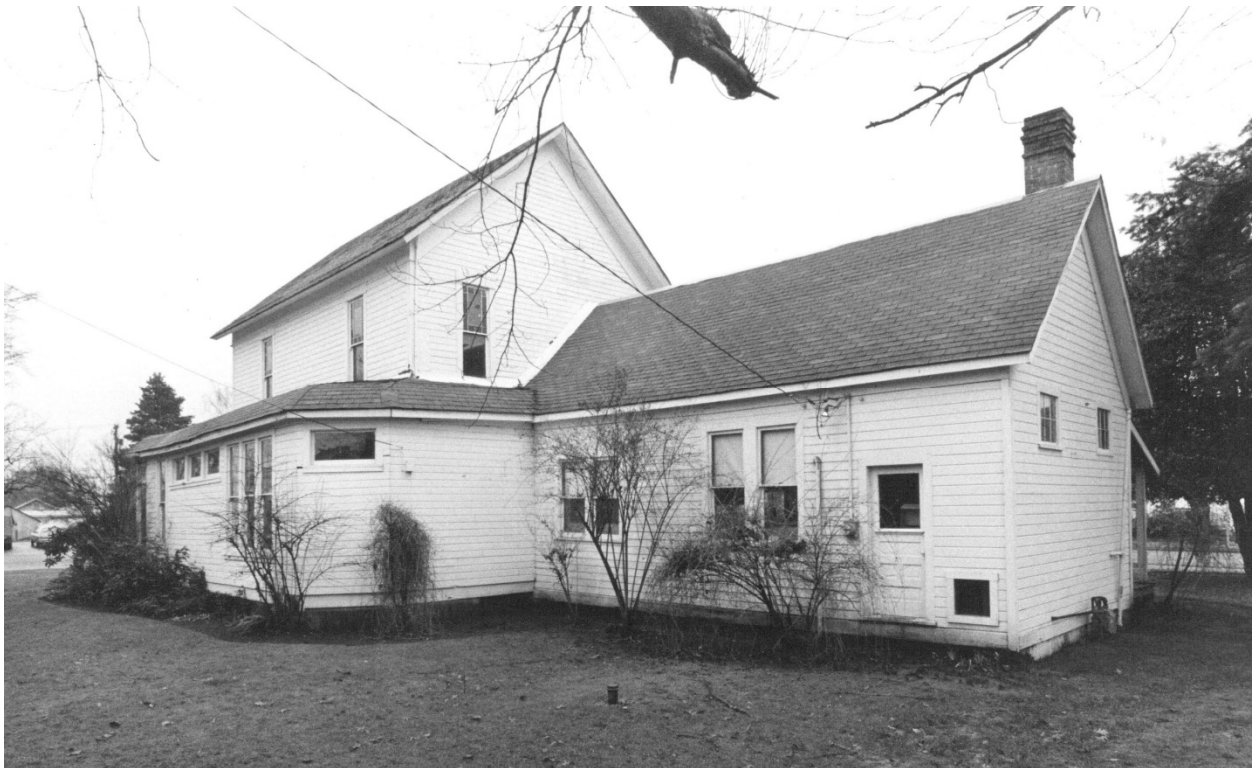
*Image from the 1976 National Register nomination, showing the enclosed west veranda. This portion of the veranda has since been restored to its original open condition.*

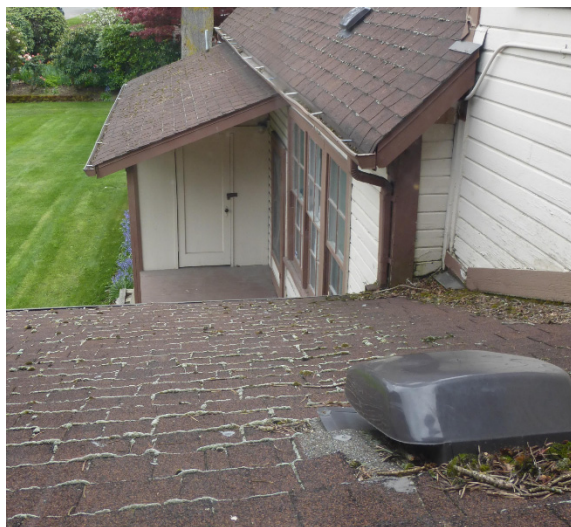
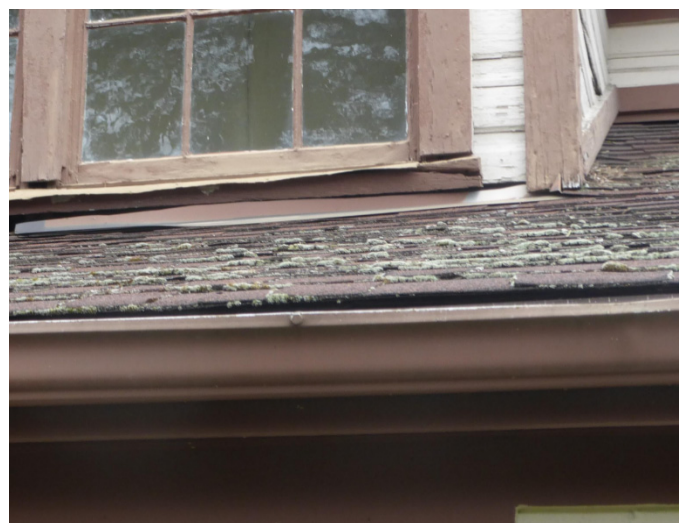
The roofs of all portions of the building, with the exception of the porch roof, are comprised of composite roof shingles with sheet metal gutters and downspouts at the lower roofs. The main gable roof of the Victorian Farmhouse does not have any gutters. The roof is currently in poor condition with extensive biological growth and damaged flashings. There is also evidence of past water intrusion in the Master Bedroom, at the ceiling by the chimney as well as at various locations at the Pioneer Cabin.

Replace composite roof shingles of all buildings with cedar shingles to match the historic configuration over plywood sheathing per structural recommendations. Replace all flashing at chimneys. Provide new gutters and downspouts at all roof locations. Chimneys should be inspected, cleaned and repointed as required.

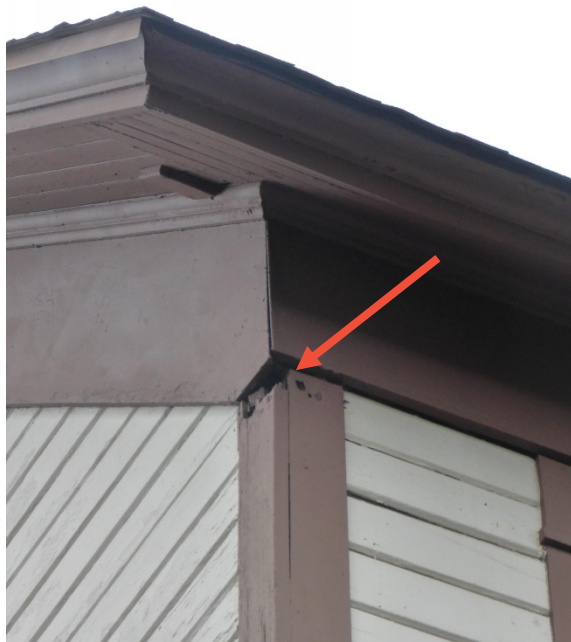
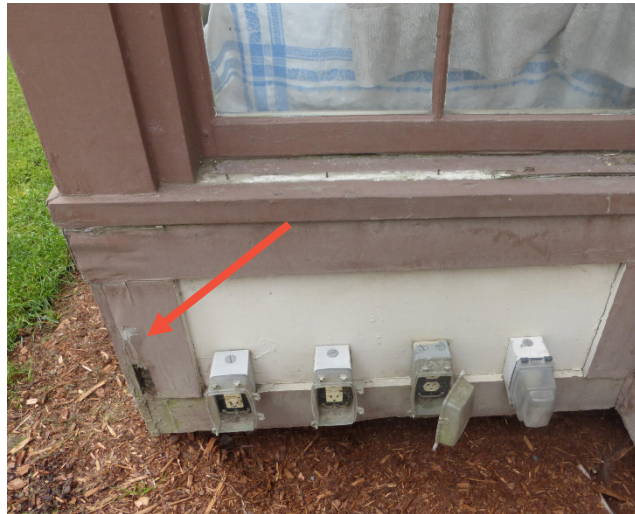
Horizontal lap siding, corner boards and wood trim are in fair to good condition with several areas needing repair. Siding and trim should also be repainted within the next two to five years. New paint should match original paint color (based on a paint analysis).

Repair siding in missing or damaged locations. Assume 5%-15% wood siding/trim replacement.

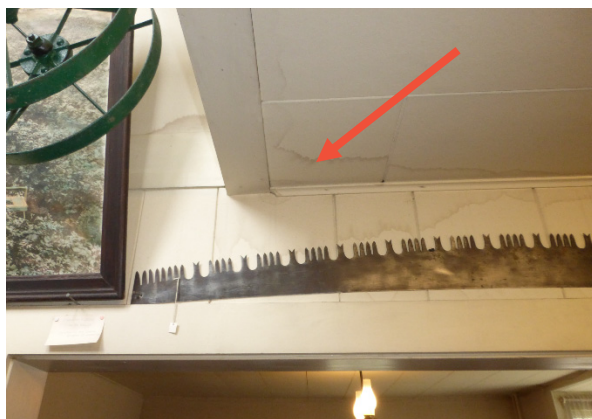
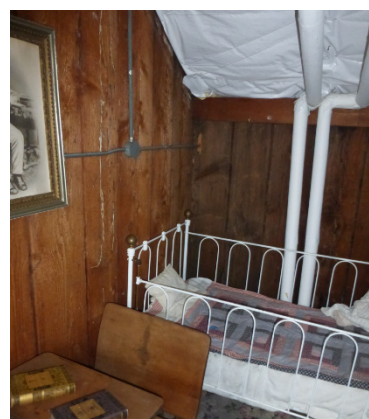
Pioneer Cabin Addition: Walls and ceiling are painted pressed fiber panels, most likely over the original wood paneling. Many of the fiber panels in ceiling areas exhibit water damage and discoloration. The attic over the Pioneer Cabin and later addition has been left unfinished.

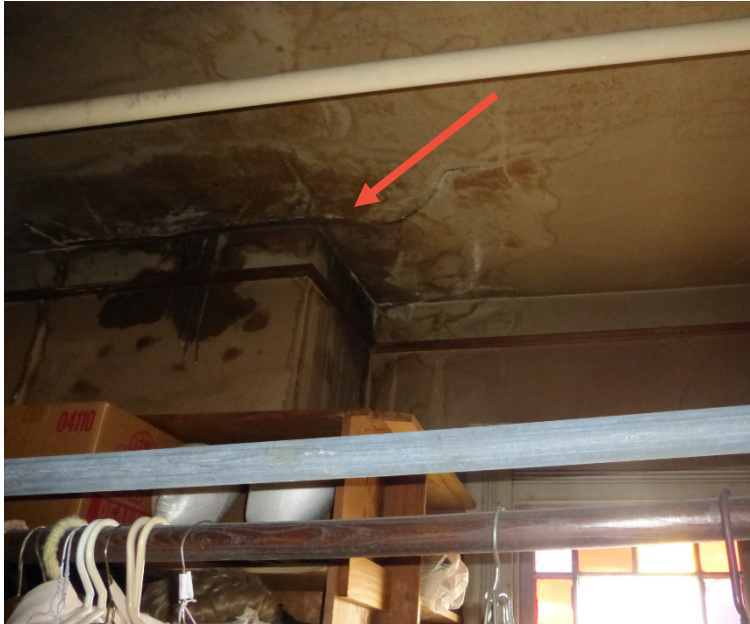
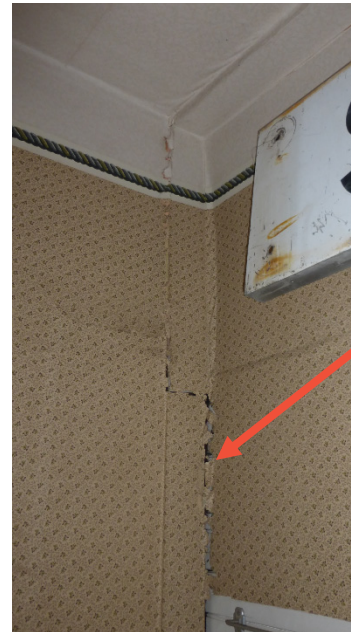
Victorian Farmhouse: The walls in the finish spaces are comprised of plaster walls (painted or covered with wallpaper) and plaster ceilings (painted). Walls in unfinished spaces (such as the attic) are exposed wood structure. The Parlor, Entry, Dining Room, staircase and upstairs bedrooms all have a decorative wood base, wood trim around the doors and windows and a picture mold that runs around the perimeter of the room. The Dining room also has a wood wainscot and a decorative wood mantelpiece around the brick fireplace. Wood base and trim elements are either stained or painted. In general, all of the finishes are in fair condition. Plaster is cracked and stained from water ingress at ceilings in many locations, wallpaper is peeling and the wood stain/lacquer exhibits weathering and surface damage.

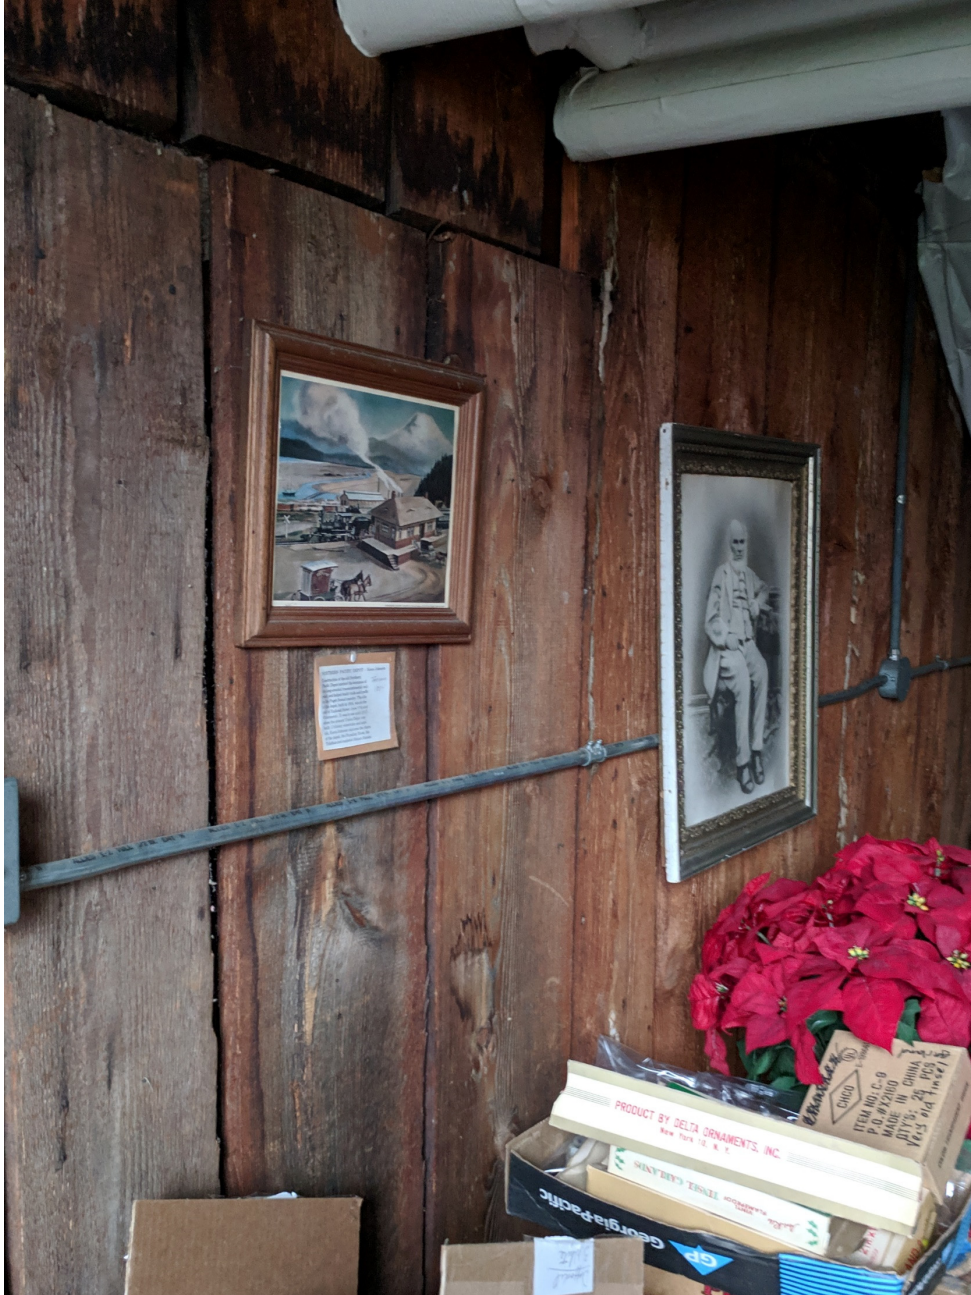
Figure A17. Portions of the original bare plank walls are visible in the cabin attic (Architectural Resources Group, April 2019).

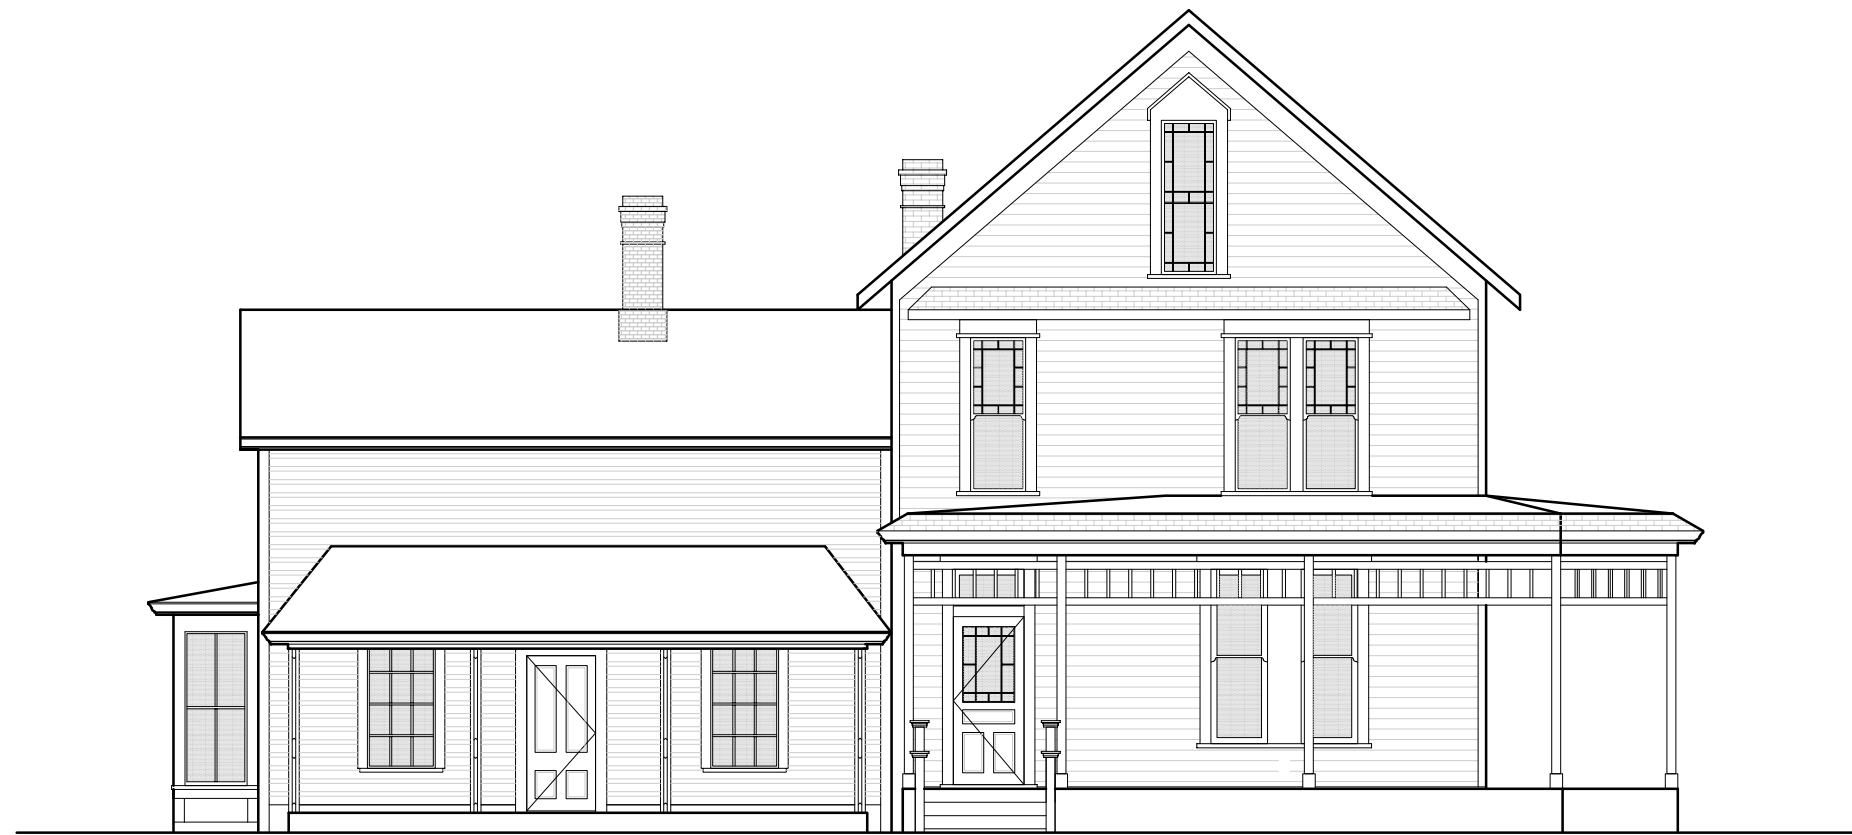
04

NORTH ELEVATION

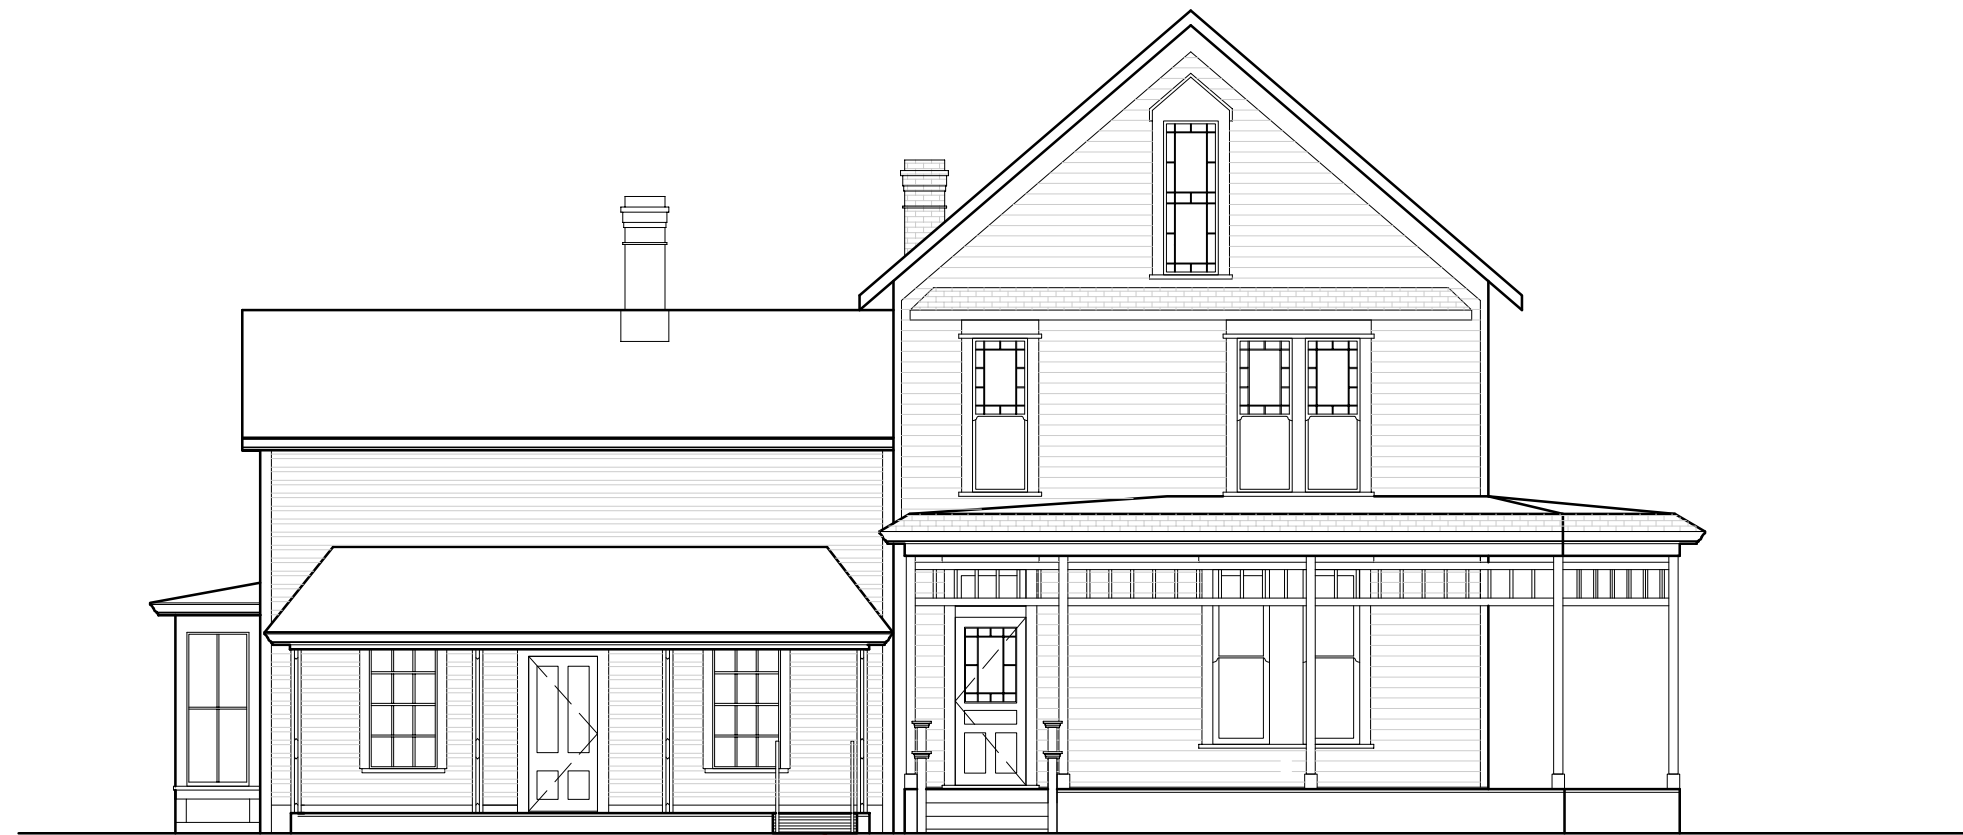
- 2ND FLOOR CEILING  
22'-10 1/2"
- 2ND FLOOR LEVEL  
13'-0 1/2"
- CABIN ATTIC LEVEL  
10'-3 1/4"
- 1ST FLOOR LEVEL  
1'-10"
- CABIN 1ST FLOOR LEVEL  
0'-10"
- GRADE LEVEL  
0'-0"

NEW RAMP TO CABIN  
PORCH

Option C: An accessible entry is created at the Pioneer Cabin by restoring the original front door to the cabin and providing a ramp that leads up to the cabin porch. An accessible entry is created at the Victorian Farmhouse by continuing the ramp from the cabin porch to the Victorian Farmhouse porch. An accessible entry is provided at the dining room by removing the closet infill, creating a small vestibule, and extending the porch deck.

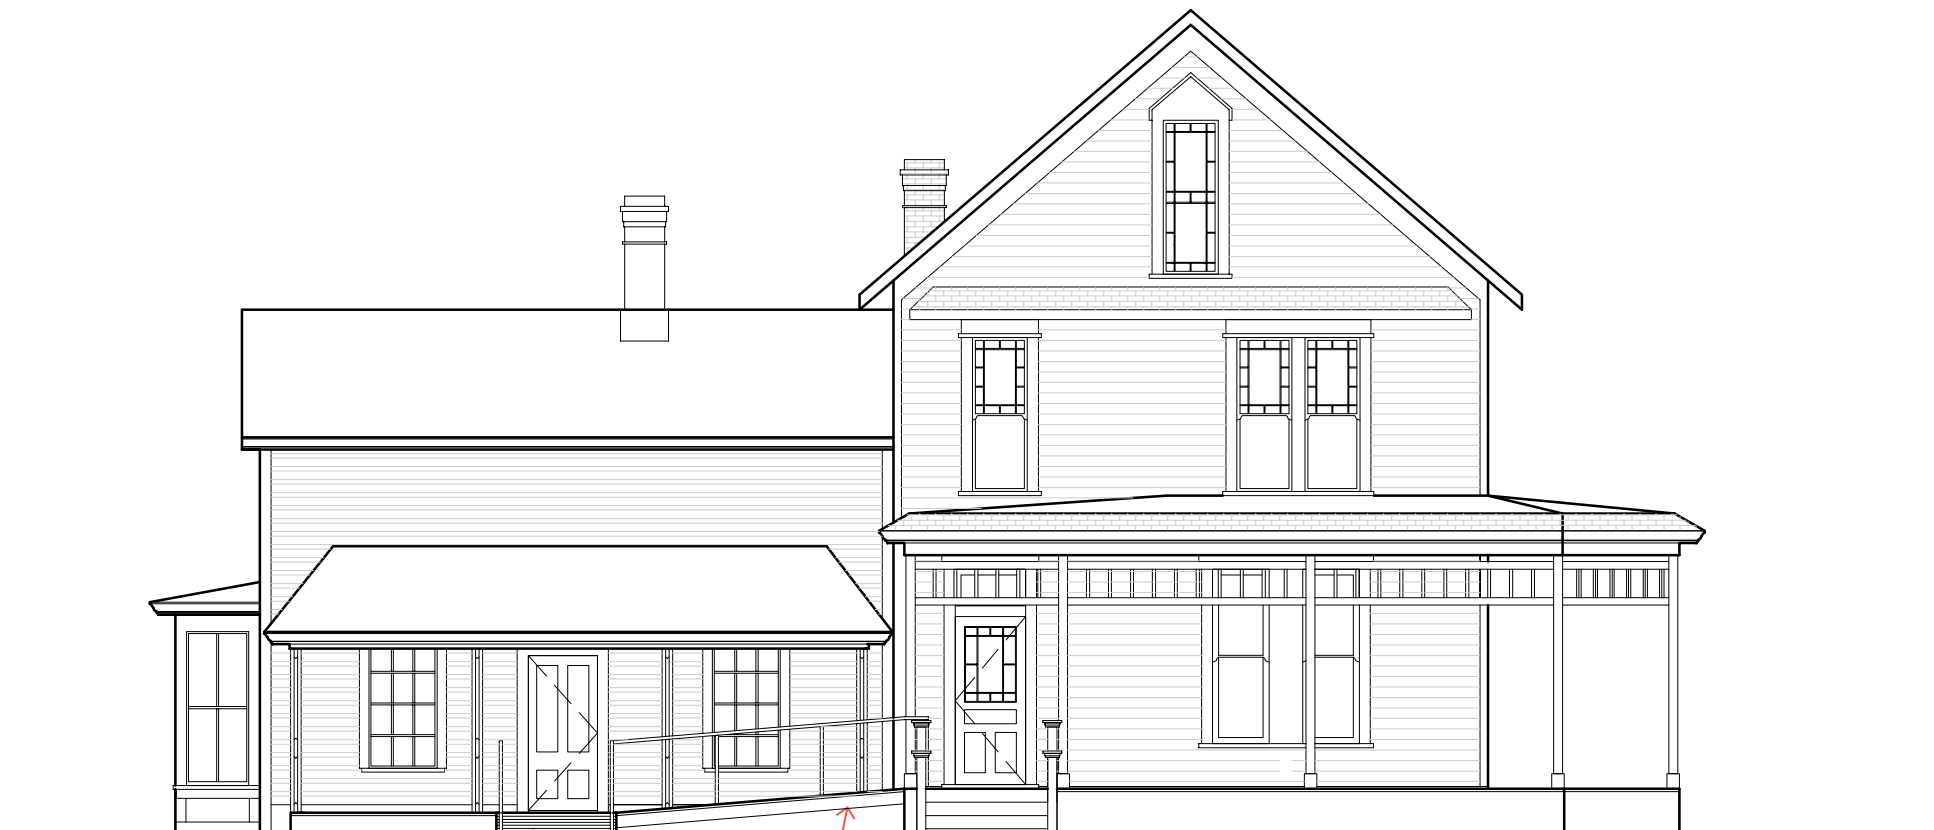
- 2ND FLOOR CEILING  
22'-10 1/2" —————
- 2ND FLOOR LEVEL  
13'-0 1/2" —————
- CABIN ATTIC LEVEL  
10'-3 1/4" —————
- 1ST FLOOR LEVEL  
1'-10" —————
- CABIN 1ST FLOOR LEVEL  
0'-10" —————
- GRADE LEVEL  
0'-0" —————

NEW RAMP TO  
CABIN PORCH

NEW RAMP TO VICTORIAN  
FARMHOUSE PORCH

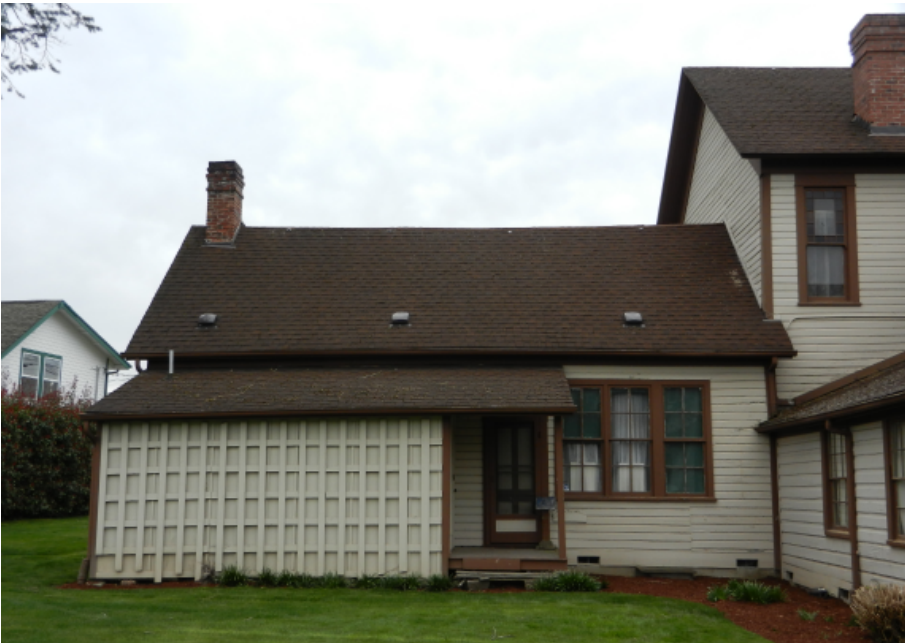
Addition of a storage shed adjoining the kitchen’s east wall.

- Replacement of cedar roof shakes that covered the main roof surfaces and replacement of the fish-scale shingles of the veranda overhang.
- Replacement of the house’s front door.
- Addition of a storage shed adjoining the kitchen’s east wall.
- Gutters and downspouts installed.
- Restoration of west elevation veranda, which had been enclosed during the building’s use as a library, including replacement of wood spindles and posts.
- Replacement of porch flooring at cabin.
- Installation of Plexiglas storm windows.

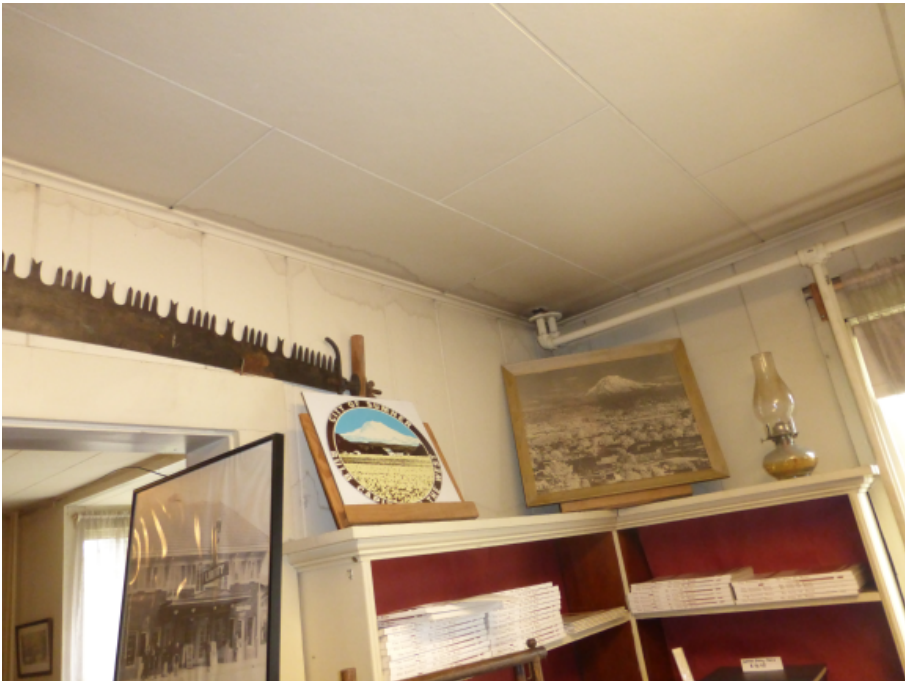
Non-historic wall and ceiling tile at Pioneer Cabin.

- Patching and repainting of plaster walls in parlor, dining room and vestibule.
- In the 1st floor cabin rooms, addition of a drop ceiling and plaster/acoustical tiles to the walls, obscuring the original ceiling and wall surfaces (including obscuring the location of the cabin’s front door).
- Subdivision of the first floor cabin space with partition walls.
- Wallpapers are evocative of the late 1800s/early 1900s but are generally not original.

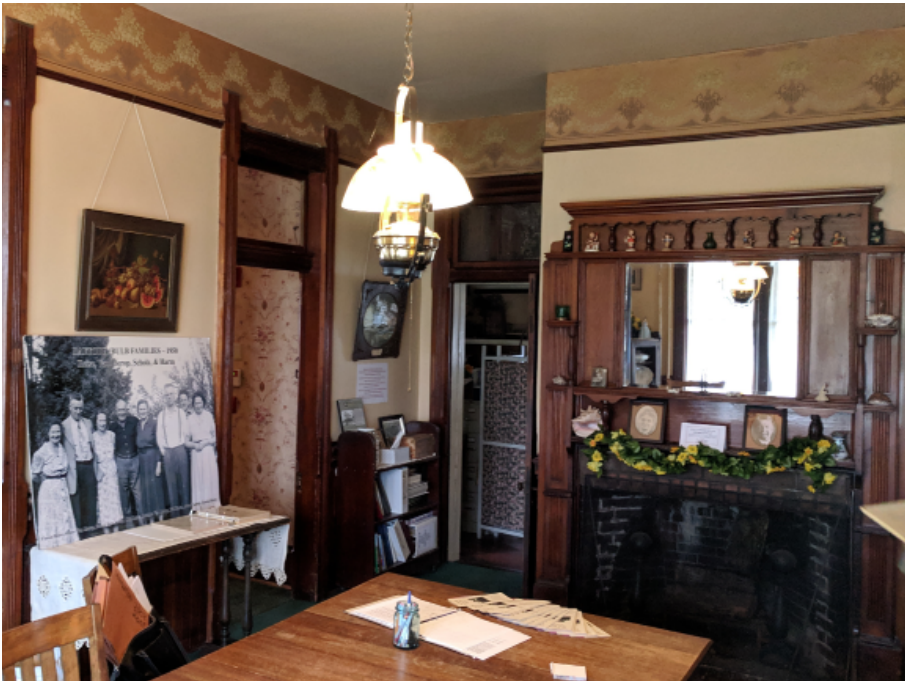
Wallpapers are evocative of the late 1800s/early 1900s but are generally not original.

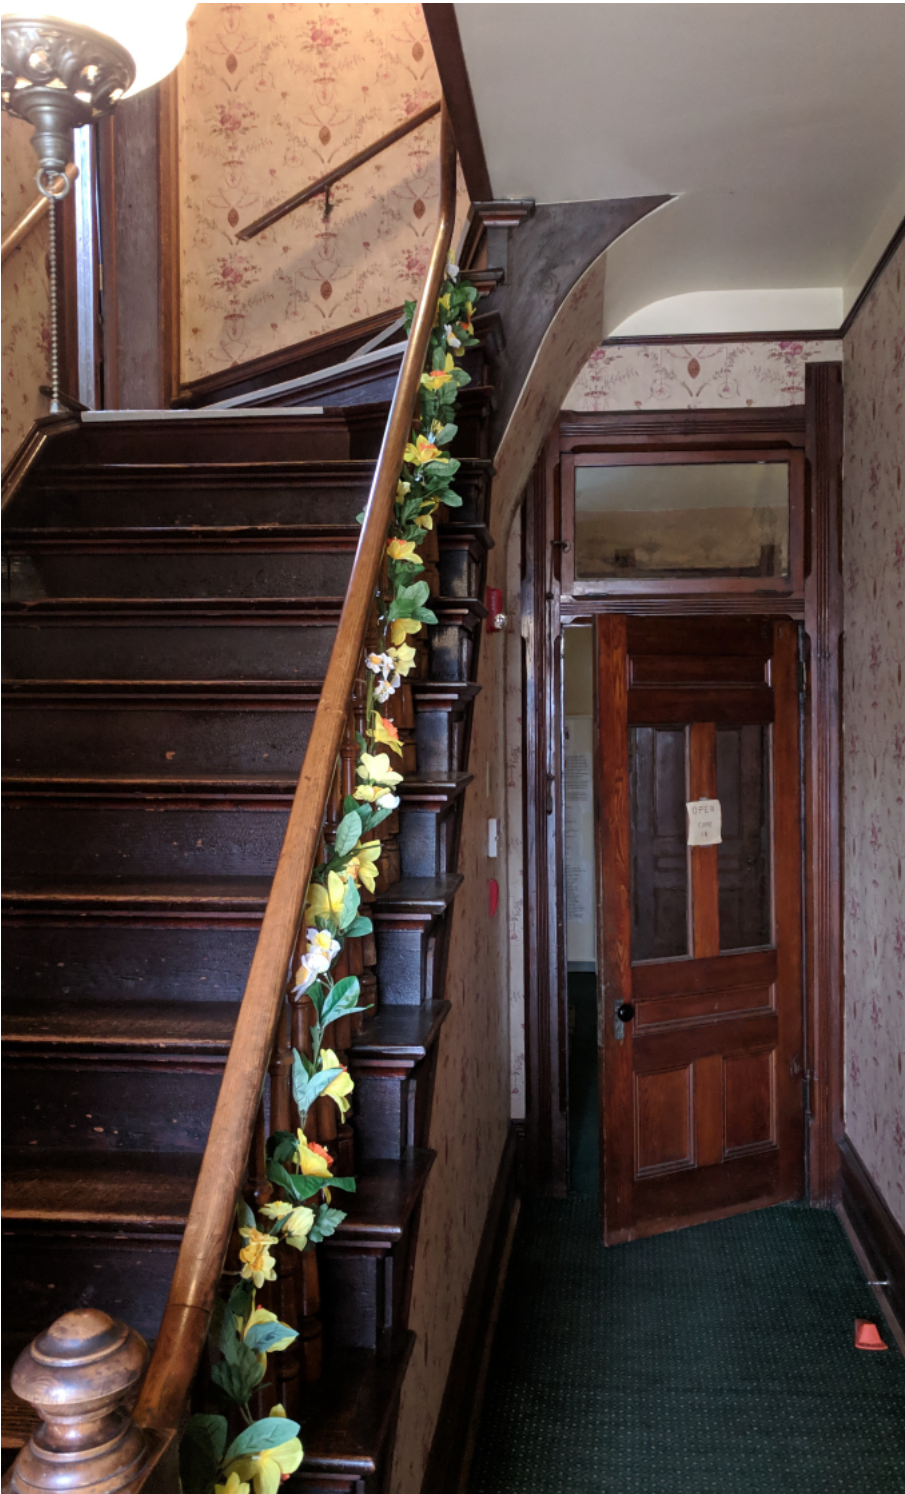
Character defining features: Historic stair, doors, and wood millwork throughout.

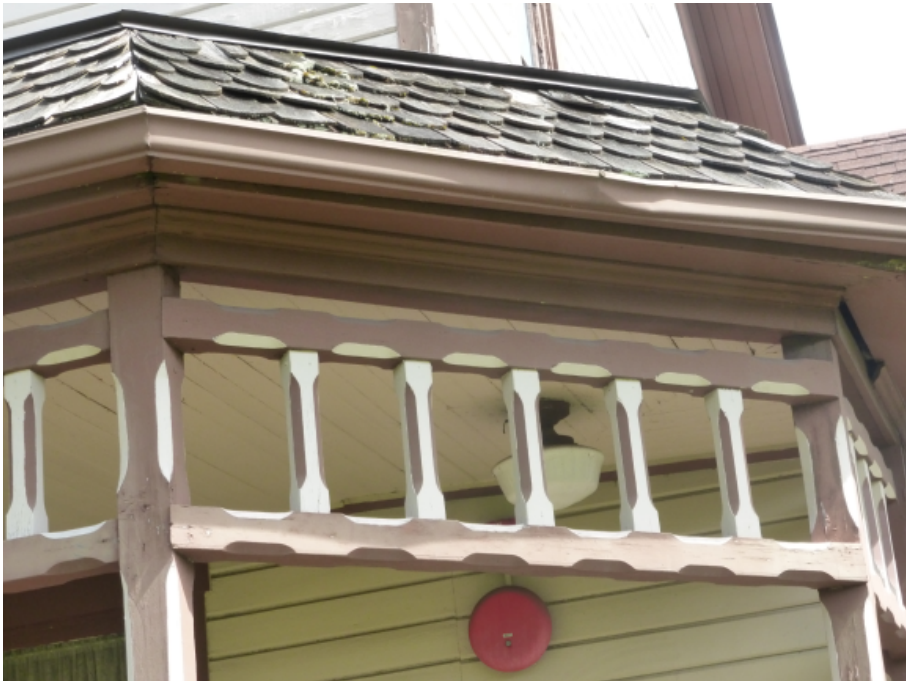
Character defining features: Wrap-around veranda, roof, and wood millwork

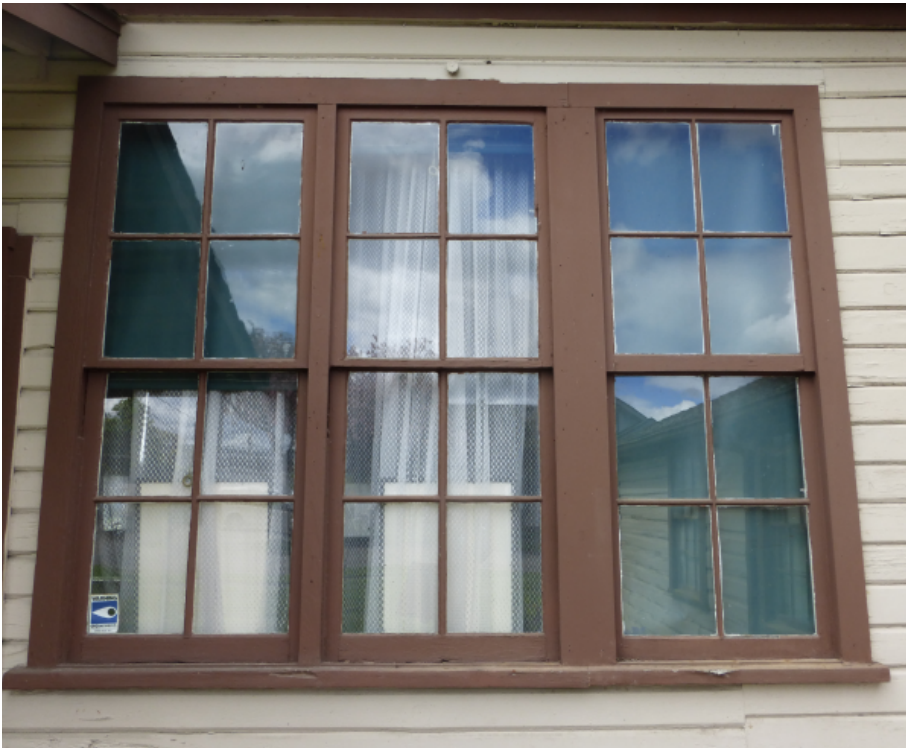
Character defining features: Historic wood double-hung windows and lap siding

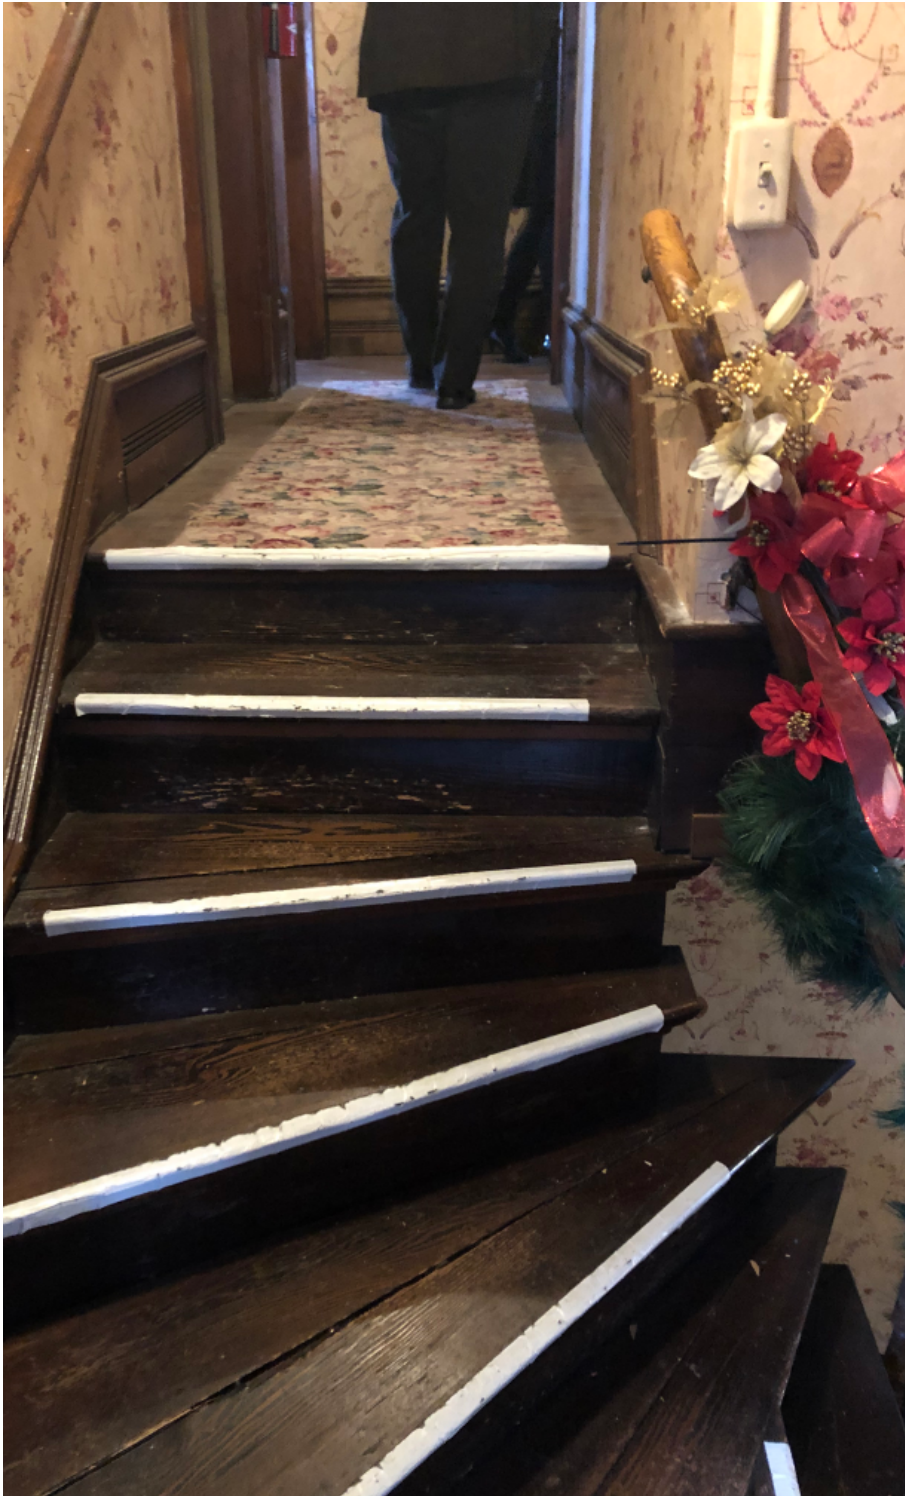
Existing winding stairs at top portion of main stair

The straight run of the main historic stair at the entry hall does meet the rise and run requirements but the existing winder steps are not compliant. ARG has reached out to the City of Sumner and it was discussed that this is acceptable considering it is a historically significant stair and as long as appropriate signage is provided to alert occupants to use caution ascending and descending the stairs due to the tight stair constraints. Visually contrasting warning strips at the nosing is recommend to remain as shown in the adjacent photo.

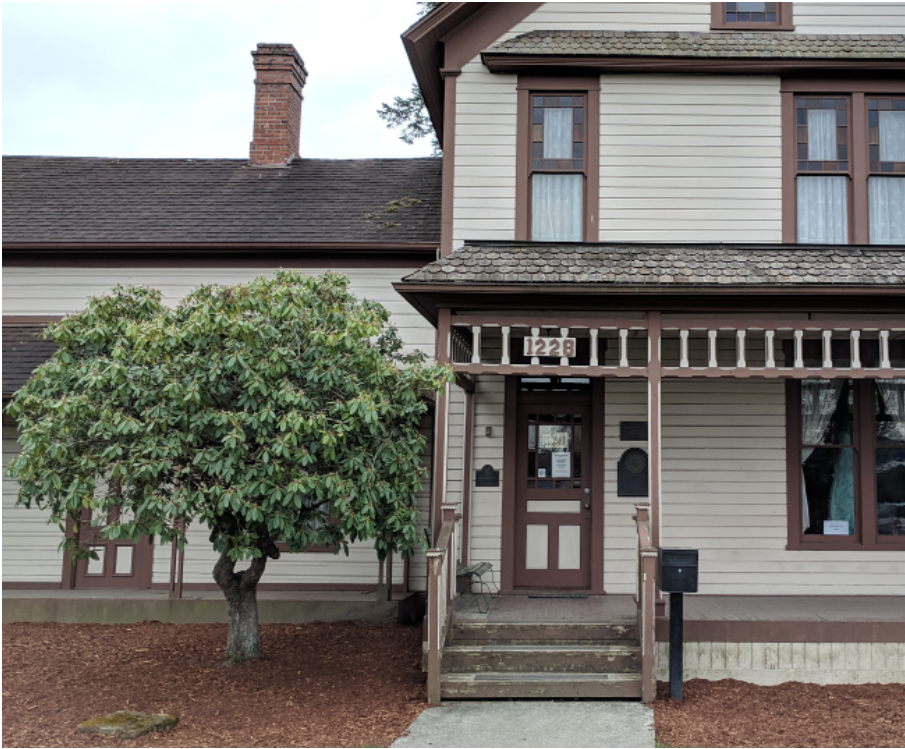
Existing non-accessible porch and front door

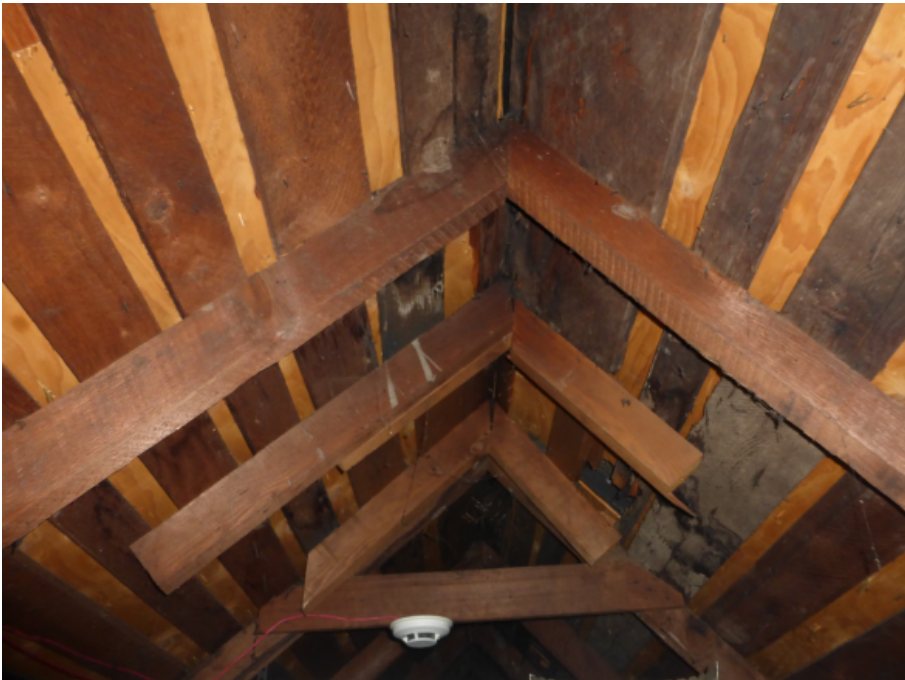
Existing attic space

It should be noted that it is not recommended to utilize the existing attic spaces for exhibit storage as they are currently being used. Storage should be off-site with the appropriate humidity and temperature control. Attic spaces will be utilized to support new mechanical systems only.

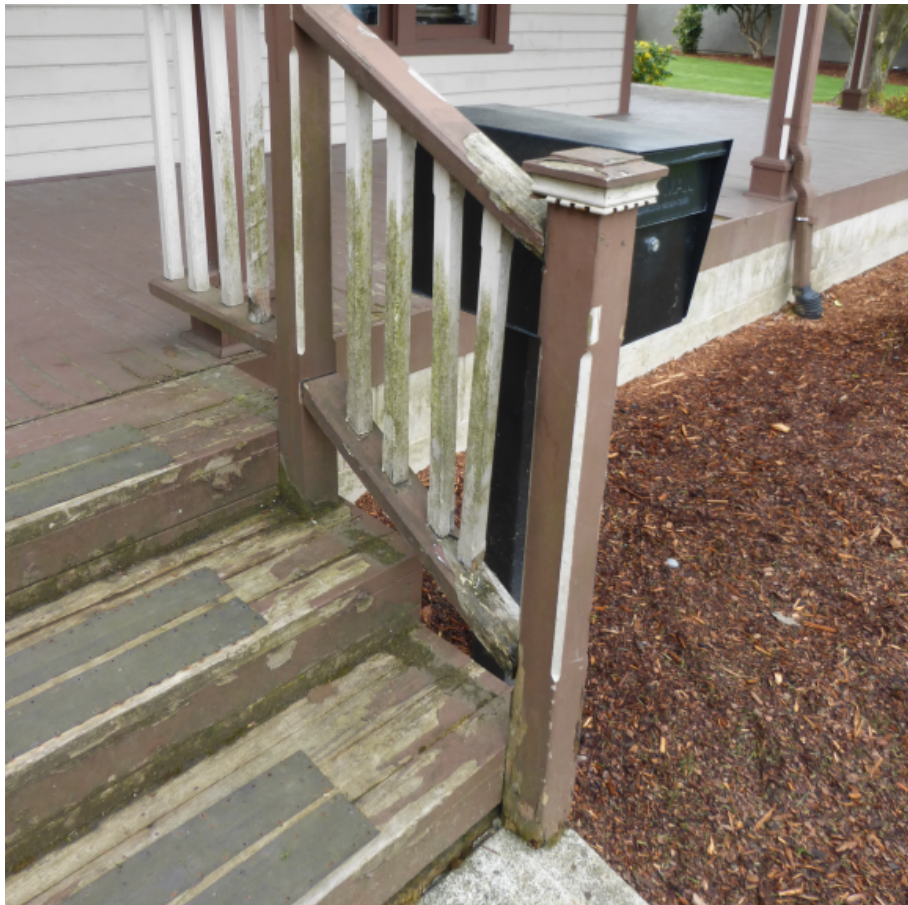
*Example of deteriorated wood at porch stairs and railings to be replaced.*

- Replace all roofing components, including low-sloped roof, cedar shingles, gutters and downspouts. Replace damaged deck components, assume 25% replacement. Replace skirt at perimeter of porch, match historic configuration and keep elevated above grade. Assume 25% replacement of missing/damaged trim components. Replace all components of two sets of stairs and handrails. Repaint entire porch, including fish-scale shingles, to match historic configuration.

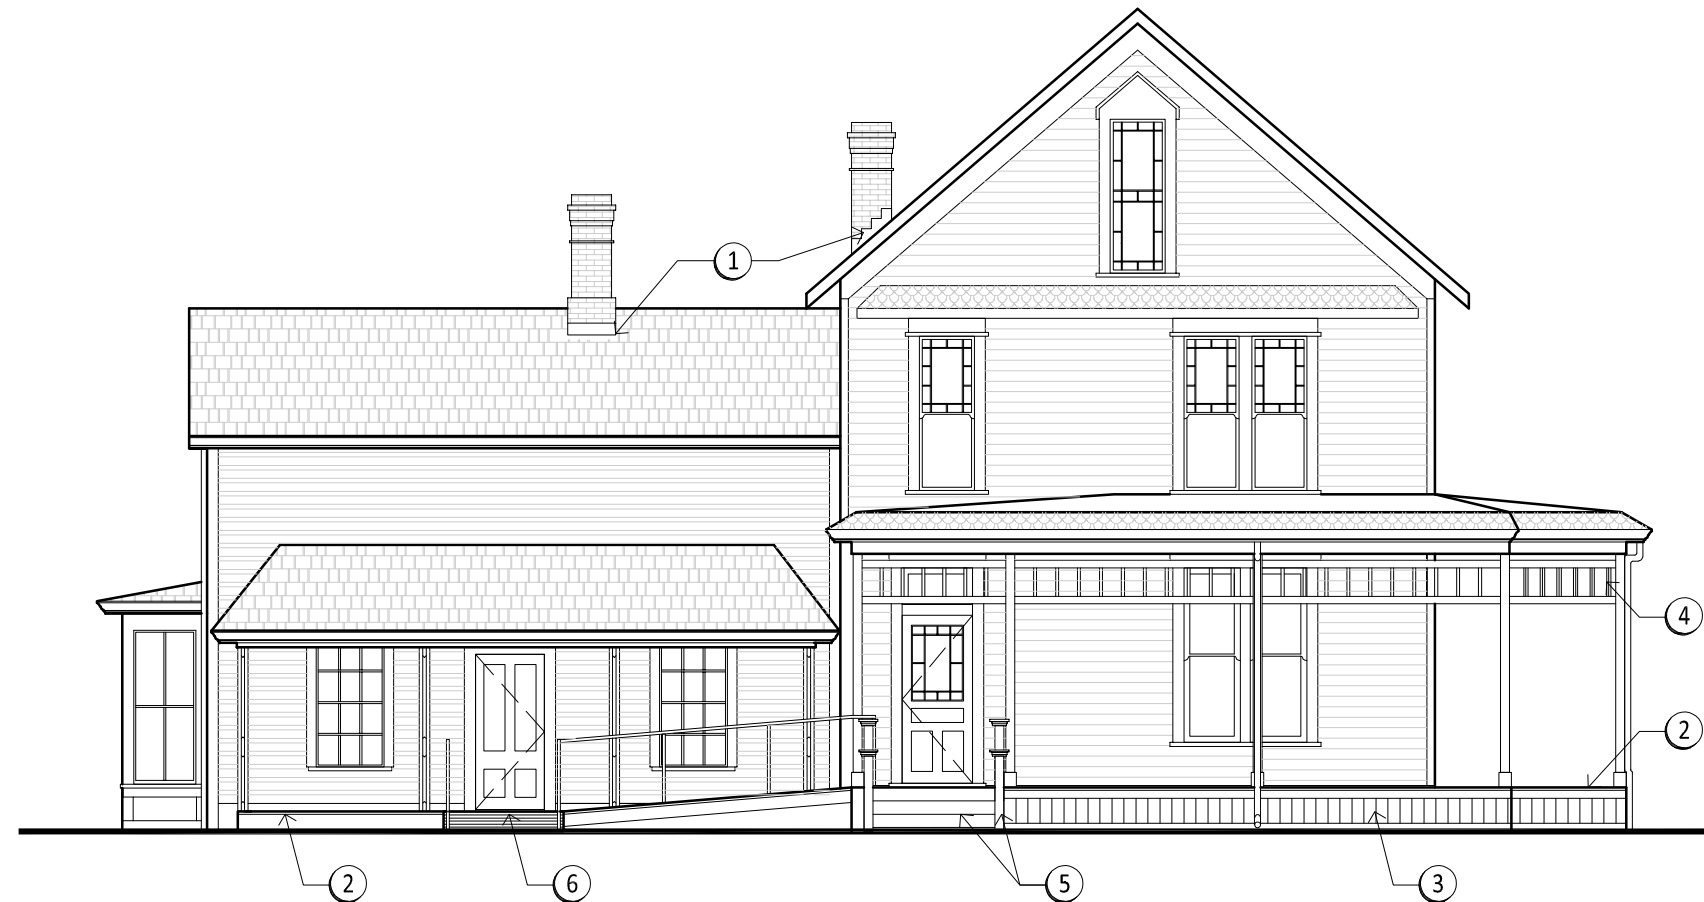
## NORTH ELEVATION

| ① REPLACE METAL FLASHING AT EXISTING CHIMNEY AND REPOINT AS REQUIRED.. | ⑤ REPLACE WOOD STAIRS AND HANDRAILS. |
| ② REPLACE DAMAGED WOOD DECKING AT VERANDA. ASSUME 25% REPLACEMENT. | ⑥ PROPOSED CONCRETE RAMP WITH METAL HANDRAILS. |
| ③ REPLACE WOOD SKIRT AT PERIMETER OF VERANDA. | ⑦ EXISTING EXTERIOR LIGHT. |
| ④ REPLACE MISSING/DAMAGED TRIM COMPONENTS AT VERANDA. ASSUME 25% REPLACEMENT. | ⑧ PROPOSED DOOR TO MATCH EXISTING. |
